# Detecting and imaging hard-to-find abandoned wells and pipelines

LAWRENCE M. GOCHIOCO, LM Gochioco & Associates, Houston, USA

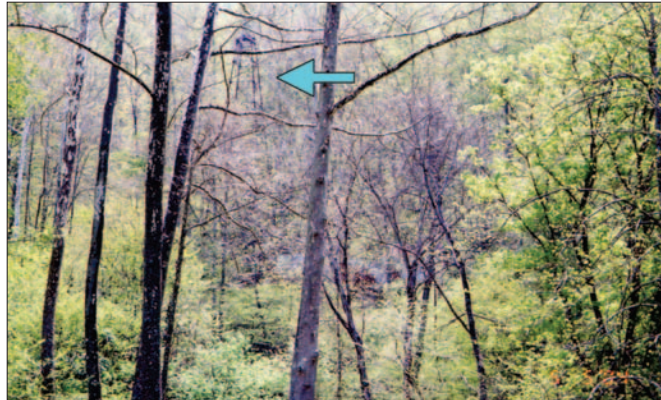
Figure 1. An abandoned oil/gas rig in a forest in the Appalachian Basin.

Unfortunately, and somewhat surprisingly, finding abandoned oil/gas rigs can frequently be difficult. For example, as shown in Figure 1, they are often barely visible on forested hillsides in the Appalachian Basin where many have been abandoned for decades. Plugging such wells is also often complicated by surface topography which makes it difficult to access the area (Figure 2). To compound the problem of detecting these abandoned wells, steel casings from many were removed and recycled during World War II. These wells were rarely plugged and, consequently, detecting them became more difficult and would require the development of portable, advanced geophysical tools.

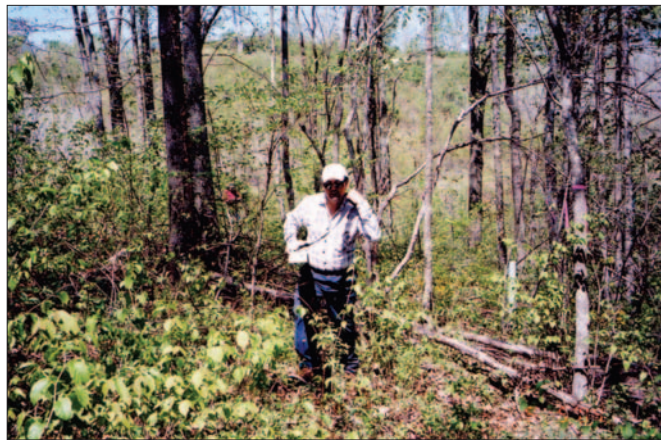
Figure 2. A site where access/data acquisition is difficult.

acquisition line could not be maintained in the heavily wooded area (see Figure 2) and the surveyor came close to the second well on the return pass. Engineers did later confirm the location of the second well.

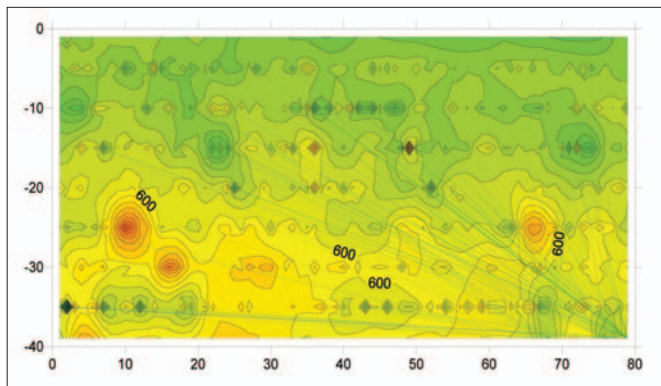
Figure 3. A twin-well problem. The first abandoned well was found near (65, -25), but finding the second (10, -25) required a digital EM survey.

In Figure 3, a digital EM image of the study area, the

first abandoned well is near coordinates (65,-25). The survey was expanded to cover a larger area which measured 40 × 80 ft and a similar signature was detected at (10,-25), 55 ft away from the first abandoned well instead of the expected 30 ft. Apparently, the drillers not only swung the rig around, but also moved an extra 25 ft for some unknown operational reason.

A similar but smaller signature near coordinates (15,-30) was interpreted to be an artifact of the survey. A straight

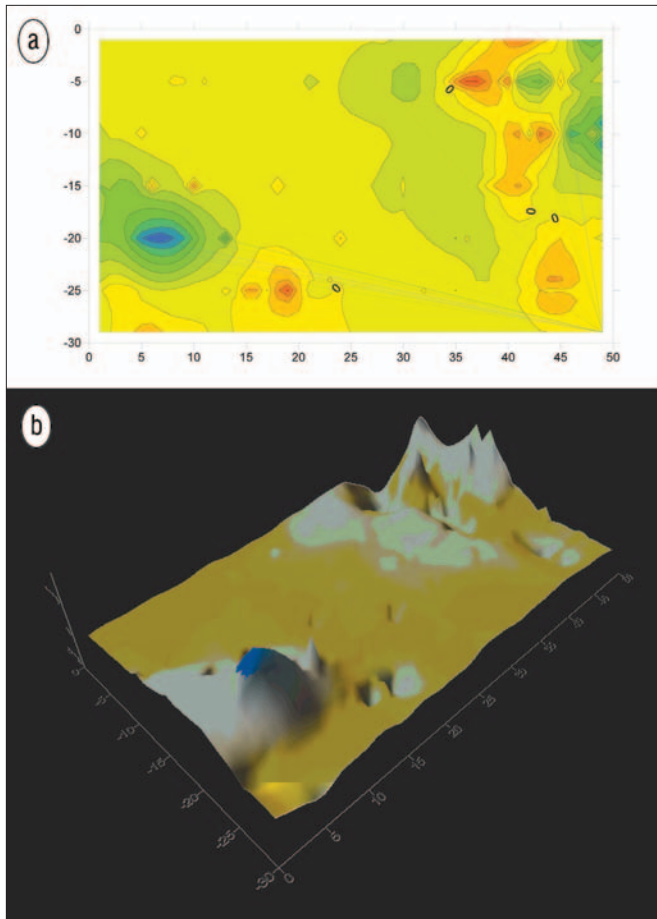
**Figure 4.** 2D (a) and 3D (b) EM images of the study area based on the In-Phase response of a source frequency of 9830 Hz.

**Abandoned well by jeep trail on hillside.** The problem was to find an abandoned well near a jeep trail on a hillside in West Virginia. Figure 4a shows the In-Phase EM image at 9830 Hz of the 50 × 30 ft study area. A large distinct (blue) peak and distinct (red) troughs may indicate an abandoned well. However, the blue positive peak is associated with an exposed aluminum culvert. Thus, one of the red troughs is likely associated with the abandoned well. In order to improve our interpretation, we generated a 3D surface expression of the EM data (Figure 4b) to highlight the recorded values.

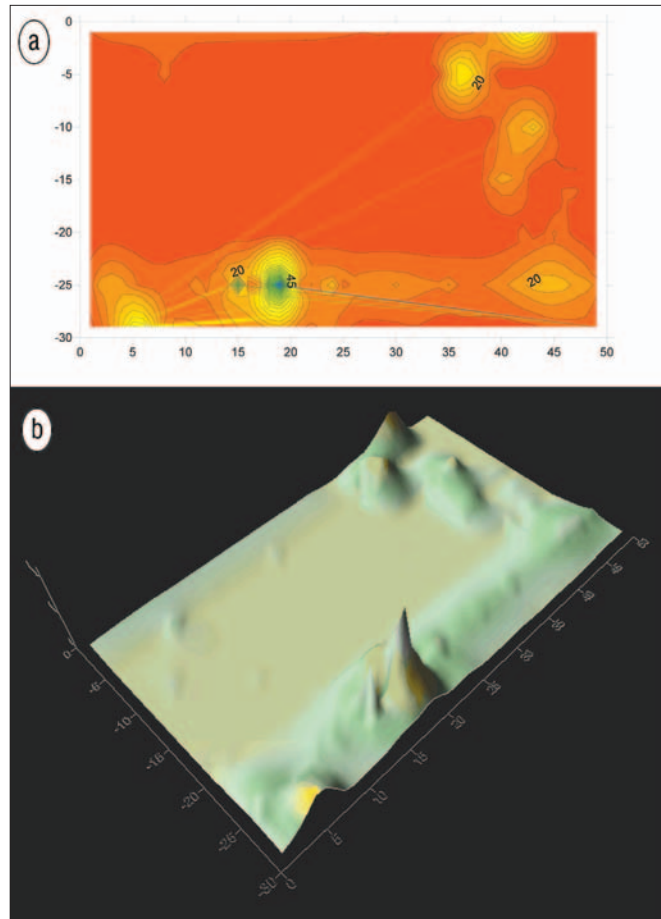
**Figure 5.** A 2D and 3D EM image of the study area based on the magnetic susceptibility response at a source frequency of 24 570 Hz. The data pinpointing the abandoned well (largest peak) connected to a legacy pipeline, suggesting that this was once a producing oil/gas well.

Resolving some uncertainties and providing better discrimination required additional EM profiles. Figure 5 shows an EM profile based on magnetic susceptibility (MS) properties at a source frequency of 24 570 Hz. The 3D EM image of this profile distinctly shows a large peak near coordinate (18,-25). The linear features of the other peaks are associated with legacy buried pipelines that measured between 2 inches and 4 inches in diameter. The short broken pipeline feature along the *y*-coordinate resulted from data acquisition footprint and should be adjusted to make the pipeline signature straight.

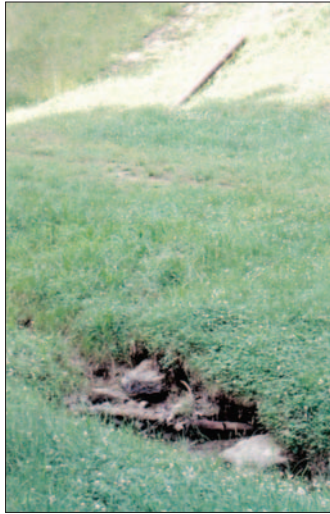
**Figure 6.** A valley floor with decommissioned pipelines evident in the background and foreground.

**Valley of legacy pipelines.** Figure 6 shows a valley with two abandoned pipelines. In the foreground is a ruptured 3-inch pipeline that runs parallel to the valley. In the background is an 8-inch pipeline that came down a hillside. These two pipelines were known to intersect at a “T” junction inside the narrow valley floor. They had been decommissioned for more than 50 years. As a result of anticipated high background noise, the data acquisition program was conducted in two phases. The first produced an EM image, source frequency of 28 290 Hz, associated with the magnetic susceptibility properties of the near-surface with (Figure 7a). The EM profile shows a lot of anomalies, including the effects of the acquisition footprint.

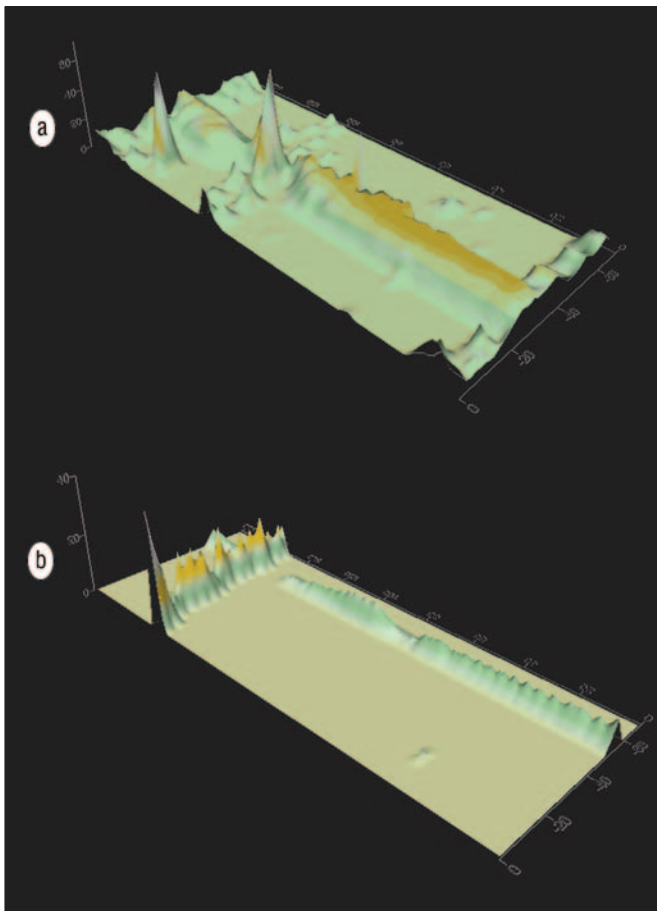
**Figure 7.** Two EM profiles collected from the same valley floor on two different dates and using different source frequencies show how highly variable the EM results can be. The 28 290 (a) and 10 530 Hz (b) profiles are shown. The abandoned well was interpreted to be near (-20, 40) which was later confirmed by excavation.

The second phase repeated the survey but incorporated techniques that would remove or minimize the effects of the acquisition footprint. In addition, different source frequencies were used to determine the resonant frequency that would maximize the excitation of near-surface anomalies. Figure 7b shows an EM image associated with magnetic susceptibility readings at 10 530 Hz. The new profile is much improved with high signal-to-noise ratio. The two legacy pipelines are now clearly shown. A small disturbance was detected near (-20, 40) and could be associated with the abandoned well. The interpretation was subsequently confirmed by excavation.

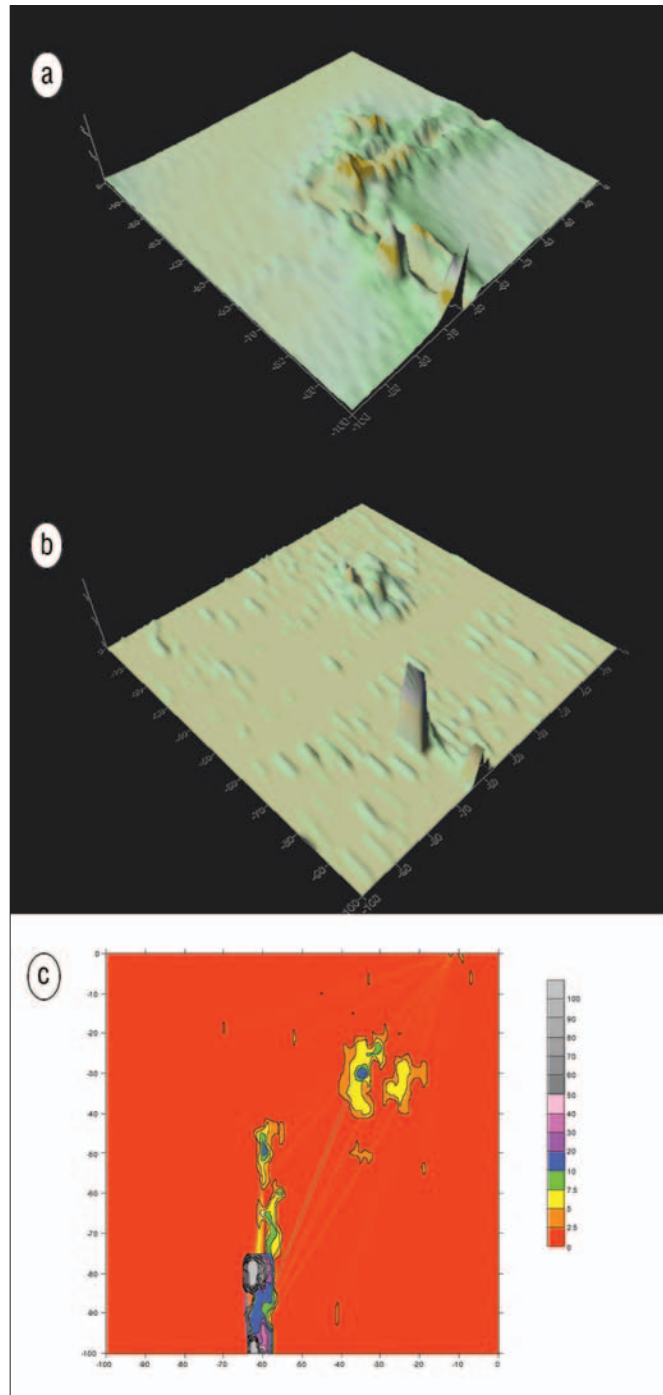
**Figure 8.** (a) The electrical conductivity properties based on a source frequency of 25 080 Hz shows a buried pipeline making a  $90^\circ$  turn. (b) By examining a different EM profile based on the magnetic susceptibility properties with a source frequency of 1530 Hz, the effects of the pipeline are filtered out, highlighting the location of abandoned well (middle). (c) A 2D map view of the study area is shown and a circular feature in blue (perhaps the actual well?) is evident inside the disturbed zone (bottom).

Figure 8a shows a 3D EM image based on the electrical conductivity properties of the near-surface having a source frequency of 25 080 Hz. An image of a pipeline is clearly visible which made a  $90^\circ$  dog-leg turn. A disturbance was also detected right next to the pipeline near (-30, -30). To enhance this anomaly, the effect of

the pipeline was attenuated by simply selecting an EM image having a much lower source frequency in order to achieve greater sounding depths. Figure 8b shows the magnetic susceptibility properties at 1530 Hz, resulting in estimated sounding depths of between 15 and 20 ft beneath the surface. The effects of the pipeline have been filtered and the same disturbed zone is more clearly defined. The disturbed zone suggested a small debris area around the well-bore or extra piping that connected the oil/gas well to the

Figure 8c shows a map view of the area. The data set was of unusually high quality because images of the disturbed zone show a circular (blue) feature that could be the abandoned well itself. In this example, both the coal company and landowner were extremely happy with the results as we were able to provide them useful information that permitted them to minimize excavation work on the property in finding the abandoned well. It also realized savings for the coal company.
